Architectural Survey of Pershing Elementary School, Fort Leonard Wood, Missouri

Sunny E. Adams and Adam D. Smith

August 2013

Final Report

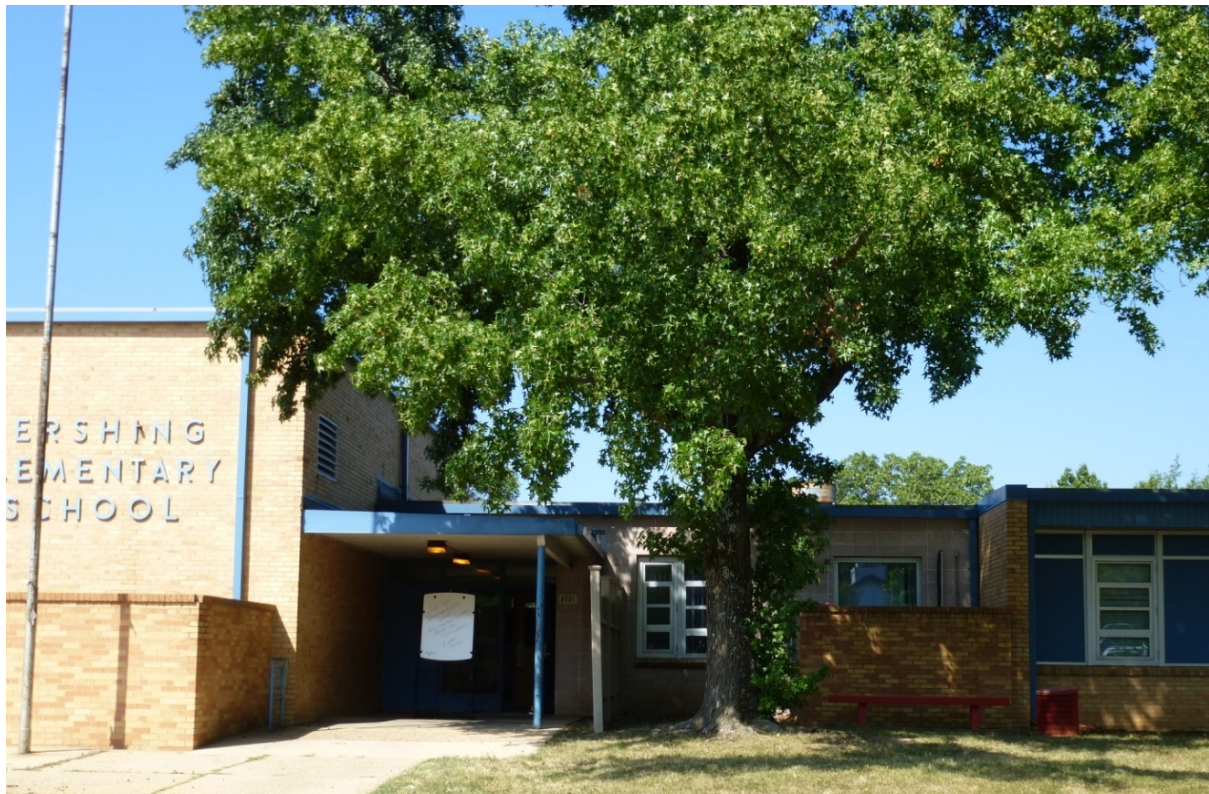
Photo 1. Main entrance on the east elevation (ERDC-CERL, 2012).

East Elevation: The east elevation faces Indiana Avenue. The main entry into the building is located in the left of center on the elevation and is defined by a recessed entry (photos 1 and 2). The entry consists of replacement metal doors, each with one narrow glass pane. A divided sidelight is located between the two doors and three fixed transoms stretch across the doors and sidelights (photo 2). The left side of the east elevation is where the double-height multi-purpose room is located (photo 3). The east elevation of the double-height wall has been modified with the removal of the original windows (photo 5). The four large window openings have been filled in with the same brick that is found on the exterior walls of the addition (photo 6). There is a set of replacement metal doors located on the far left side of the double-height wall (photo 8) and large letters spelling out "PERSHING ELEMENTARY SCHOOL" are placed on the brick exterior wall on the upper right corner of the double-height wall (photo 4). A newer air conditioning unit shielded by a brick screen wall addition is located below the lettering (photo 7). The far-left side of the east elevation is one-story in height (photo 9).

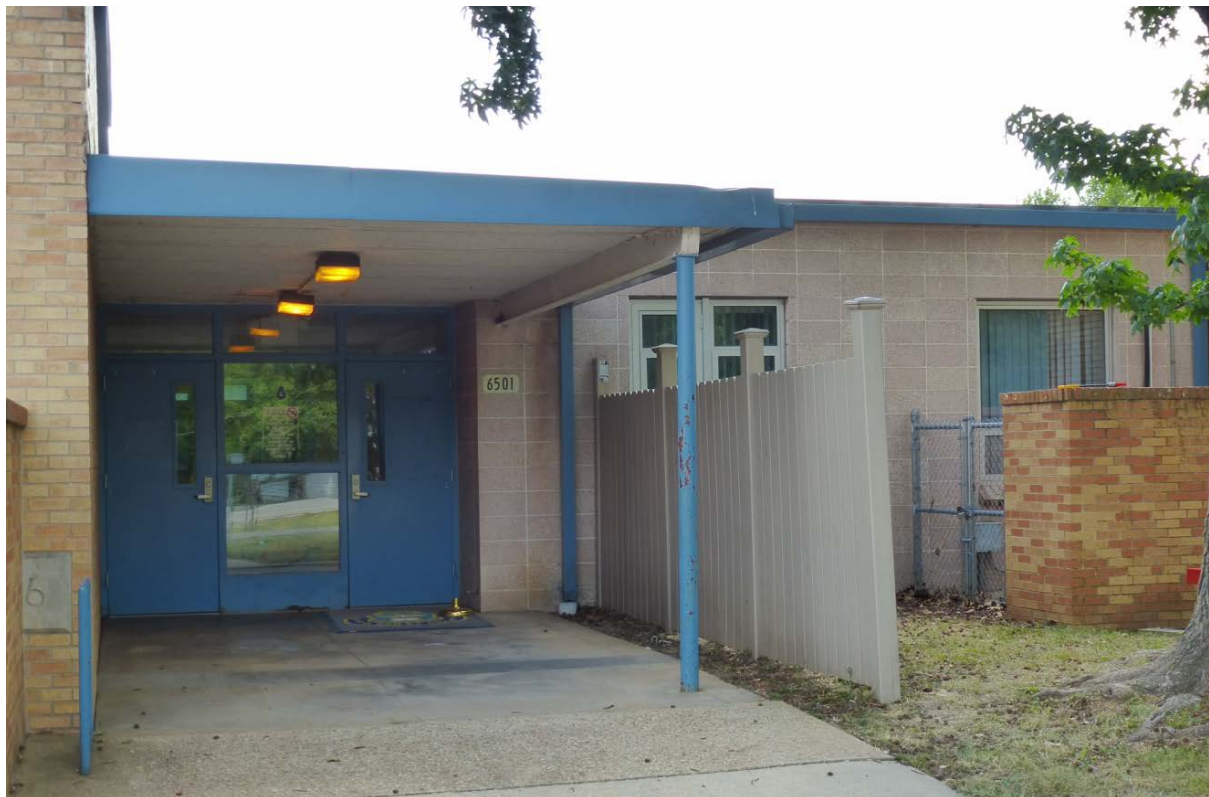
Photo 2. Replacement entry doors and sidelight of the main entry on the east elevation (ERDC-CERL, 2012).

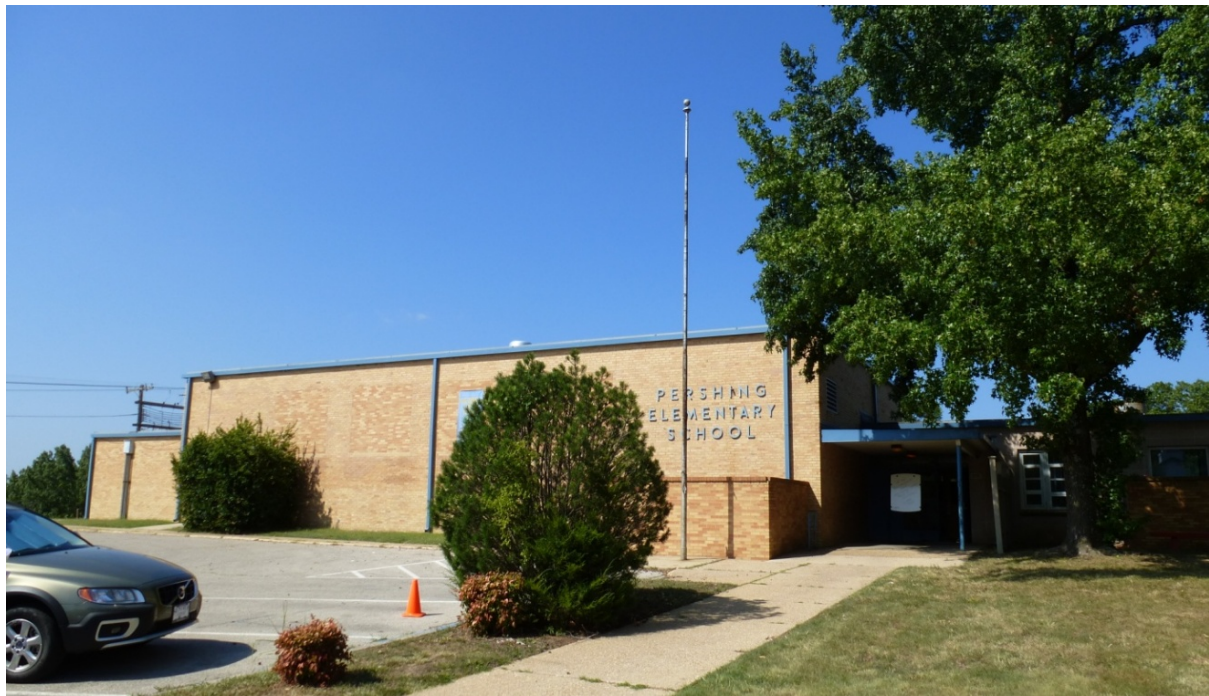
Photo 3. Left side of the east elevation (ERDC-CERL, 2012).

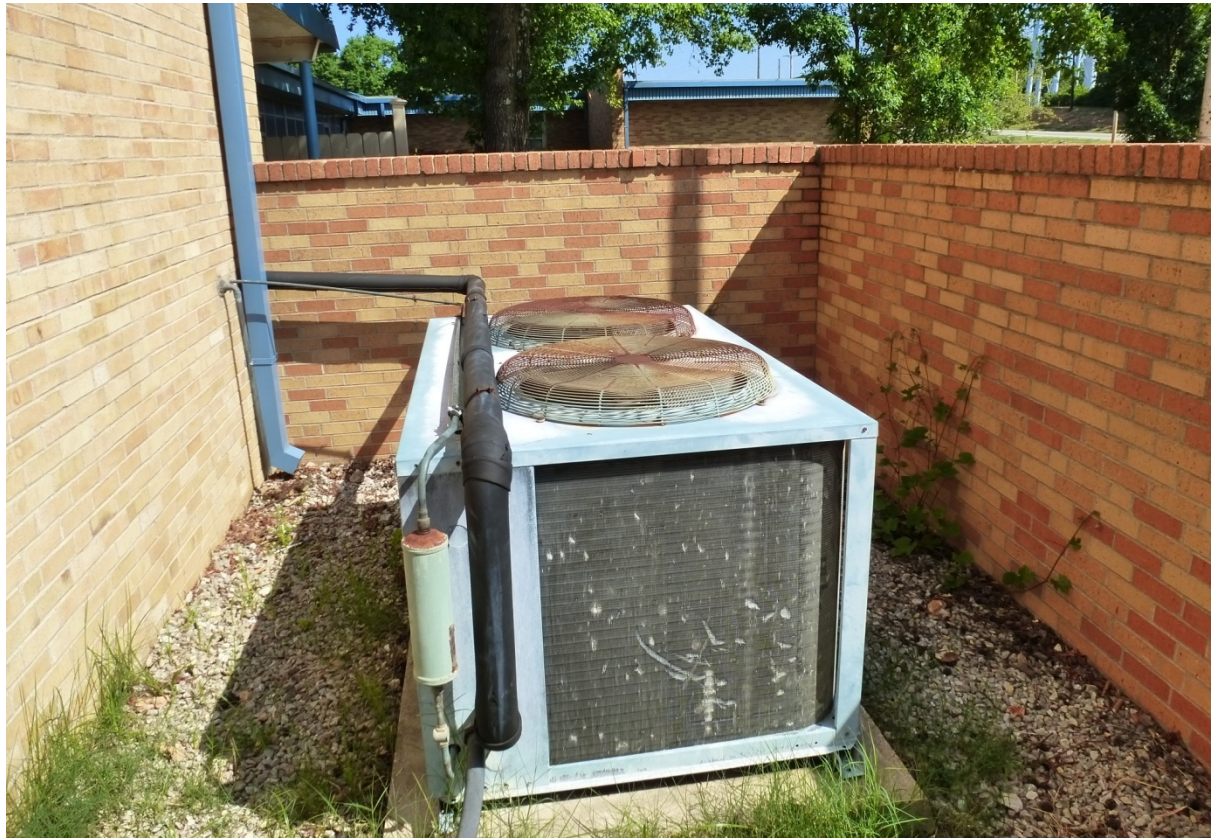
Photo 7. Air-conditioning unit addition with newer brick enclosure walls (ERDC-CERL, 2012).

The exterior of the building has been modified over the years, and the major alteration is the window pattern with the replacement of the original windows with the current windows, along with the modification of replacement doors and the construction of the two additions. The one-story exterior is dominated with walls of combination of porcelain enamel metal panels and bright aluminum windows. The windows have brick windowsills and rest on brick walls. The exterior of the classroom are defined with two four-pane awning-style windows and five panels (photo 18). There are several replacement light fixtures (photo 16) and only one original light fixture intact (photo 17). Most of the original "mudscrapers" used for shoes are intact near the entries (photo 24). Several air-conditioning units have been installed outside of each interior space. Brick screen walls have been constructed to hide the units (photo 7).

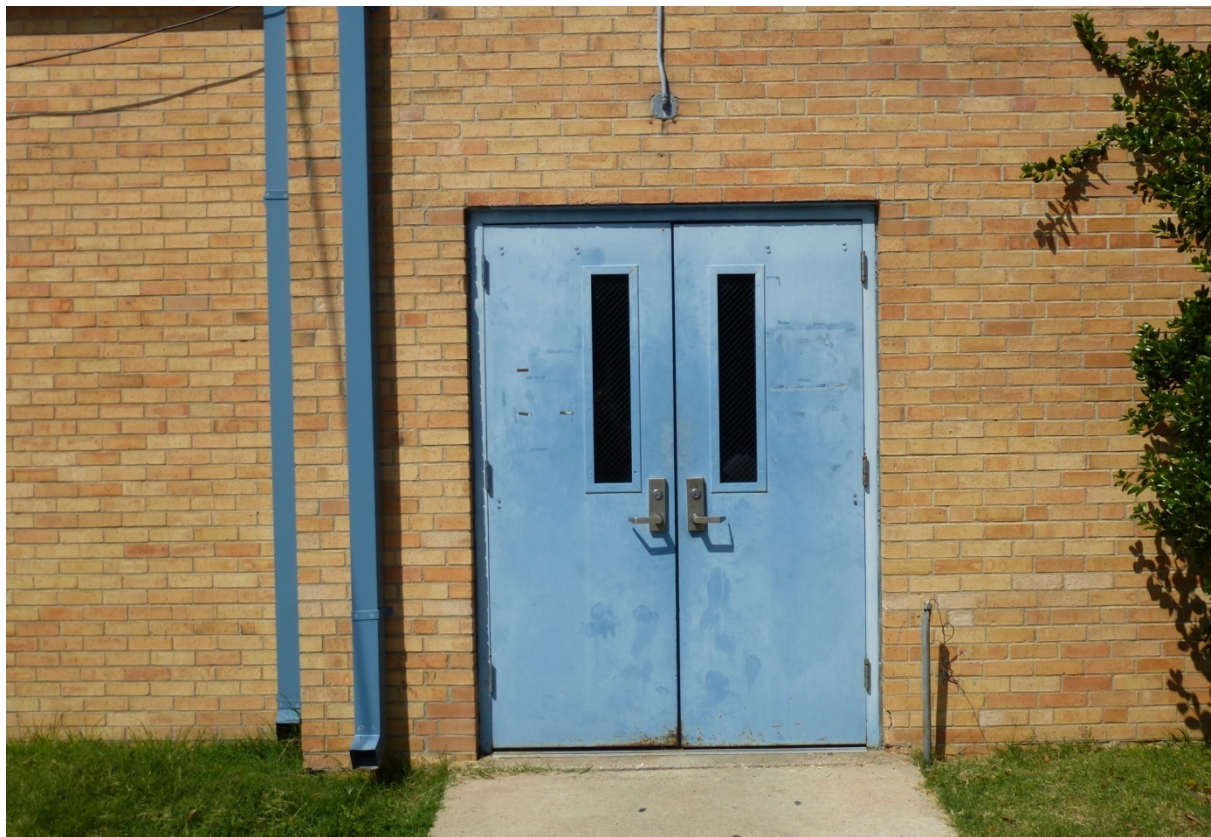
Photo 8. Replacement metal doors into the multi-purpose room (ERDC-CERL, 2012).

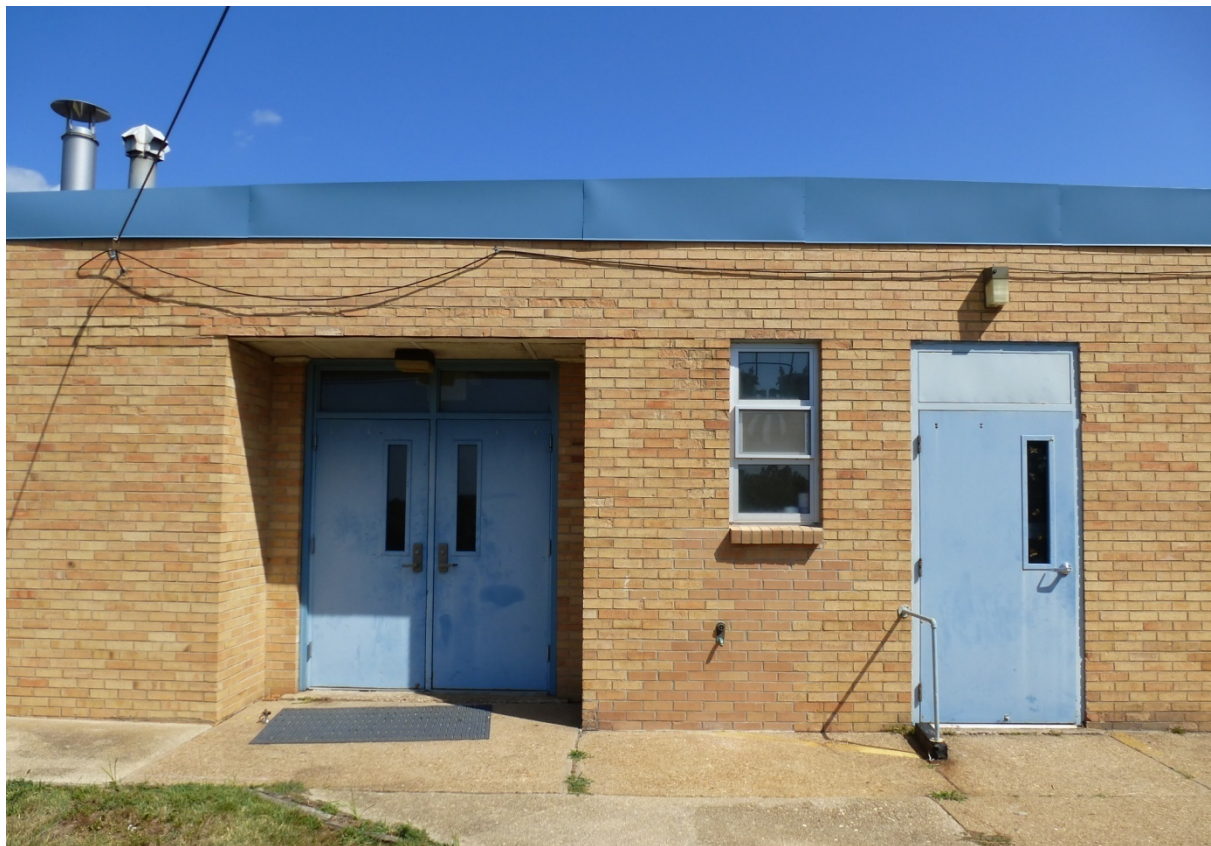
Photo 10. Replacement entry doors and replacement window on the south elevation (ERDC-CERL, 2012).

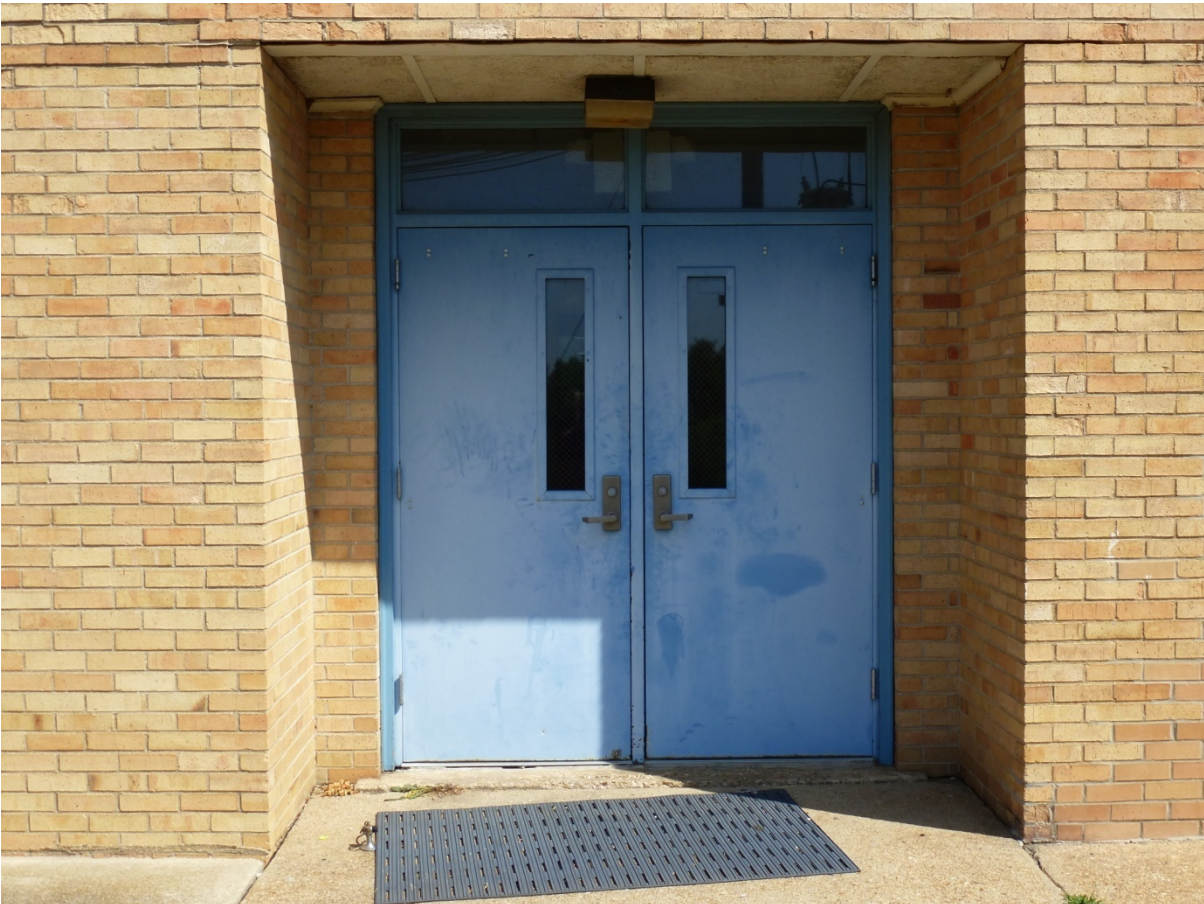
Photo 12. Closeup of replacement entry doors into the north-south corridor (ERDC-CERL, 2012).

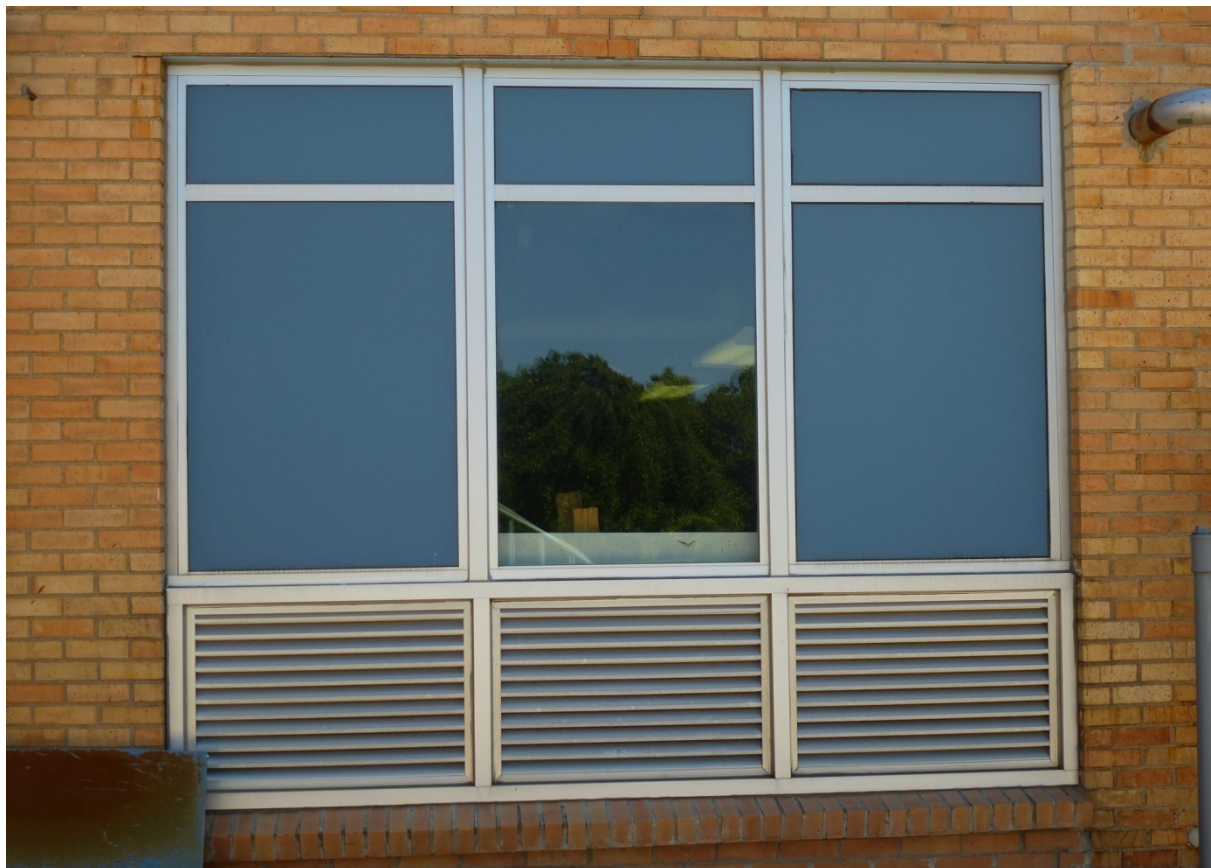
Photo 14. Closeup of replacement bright aluminum windows with metal louvered vents and panel inserts on the west elevation of the boiler room (ERDC-CERL, 2012).

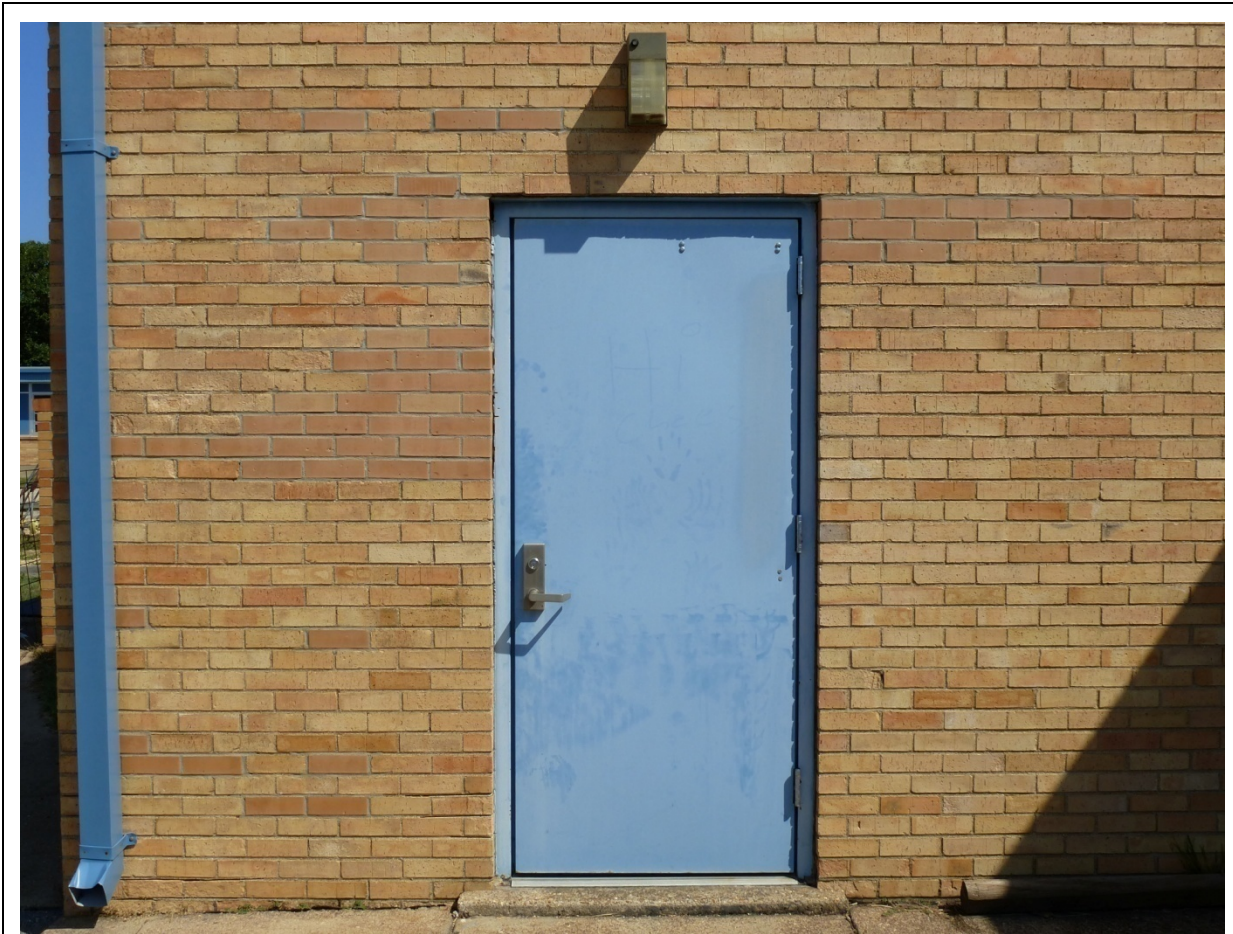
Photo 15. Replacement metal door on the far left side of the south elevation (ERDC-CERL, 2012).

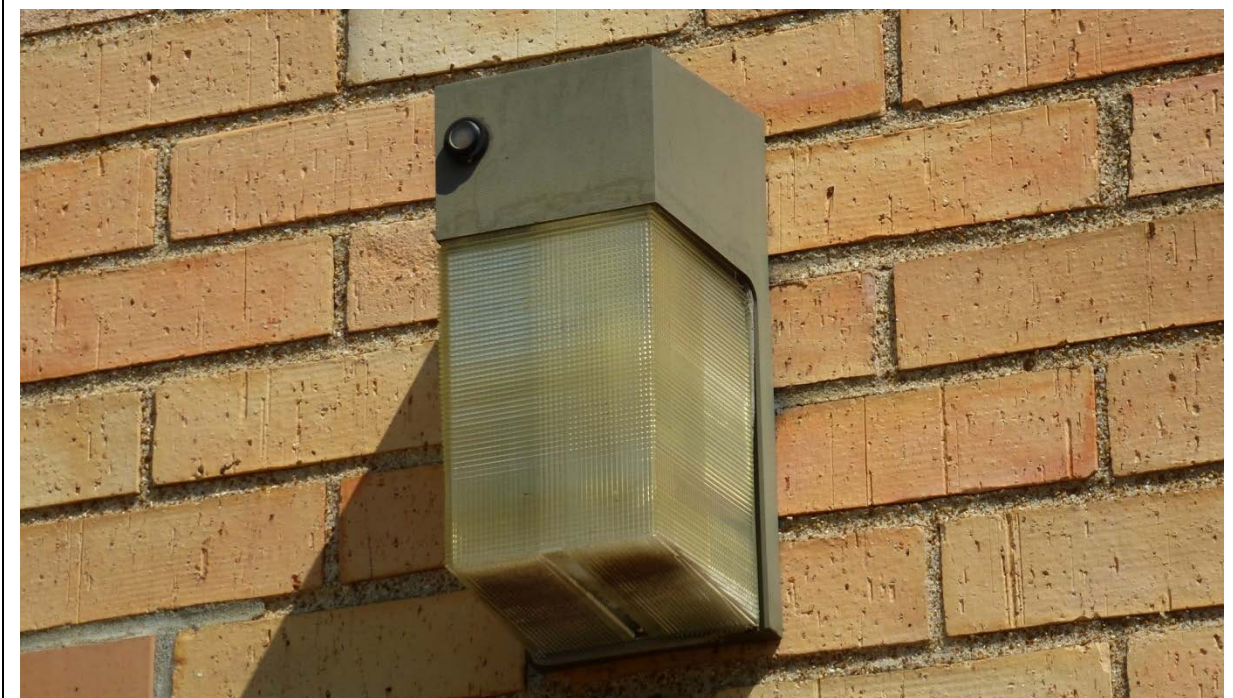
Photo 16. Replacement light fixture above the door on the far left side of the south elevation (ERDC-CERL, 2012).

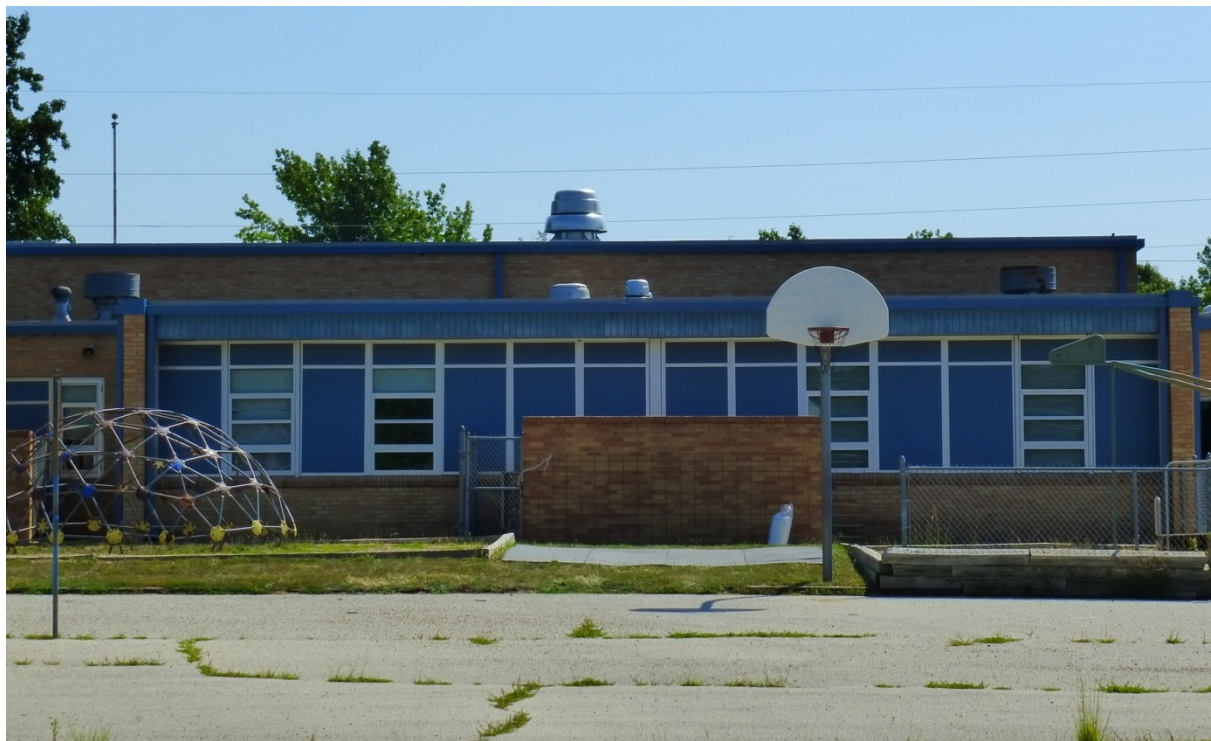
Photo 18. Modified window pattern with replacement bright aluminum windows and panel inserts on the right side of the west elevation of the original school portion (ERDC-CERL, 2012).

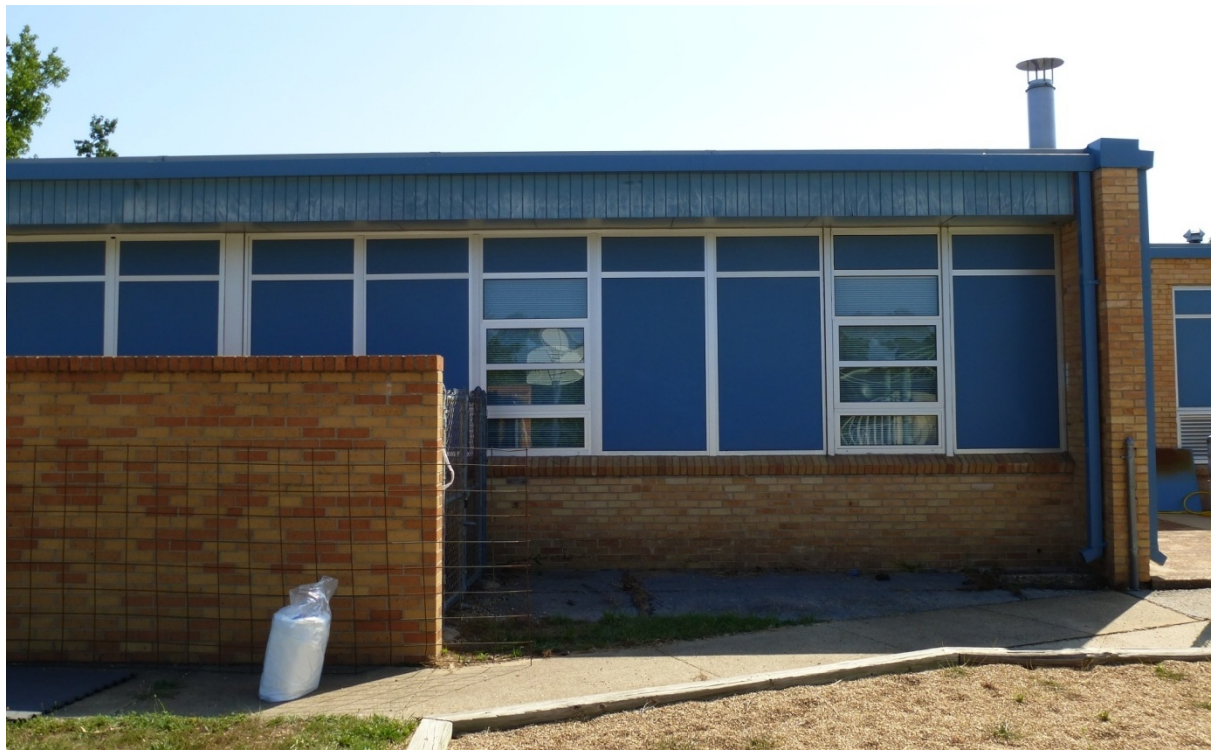
Photo 19. Closeup of replacement windows (ERDC-CERL, 2012).

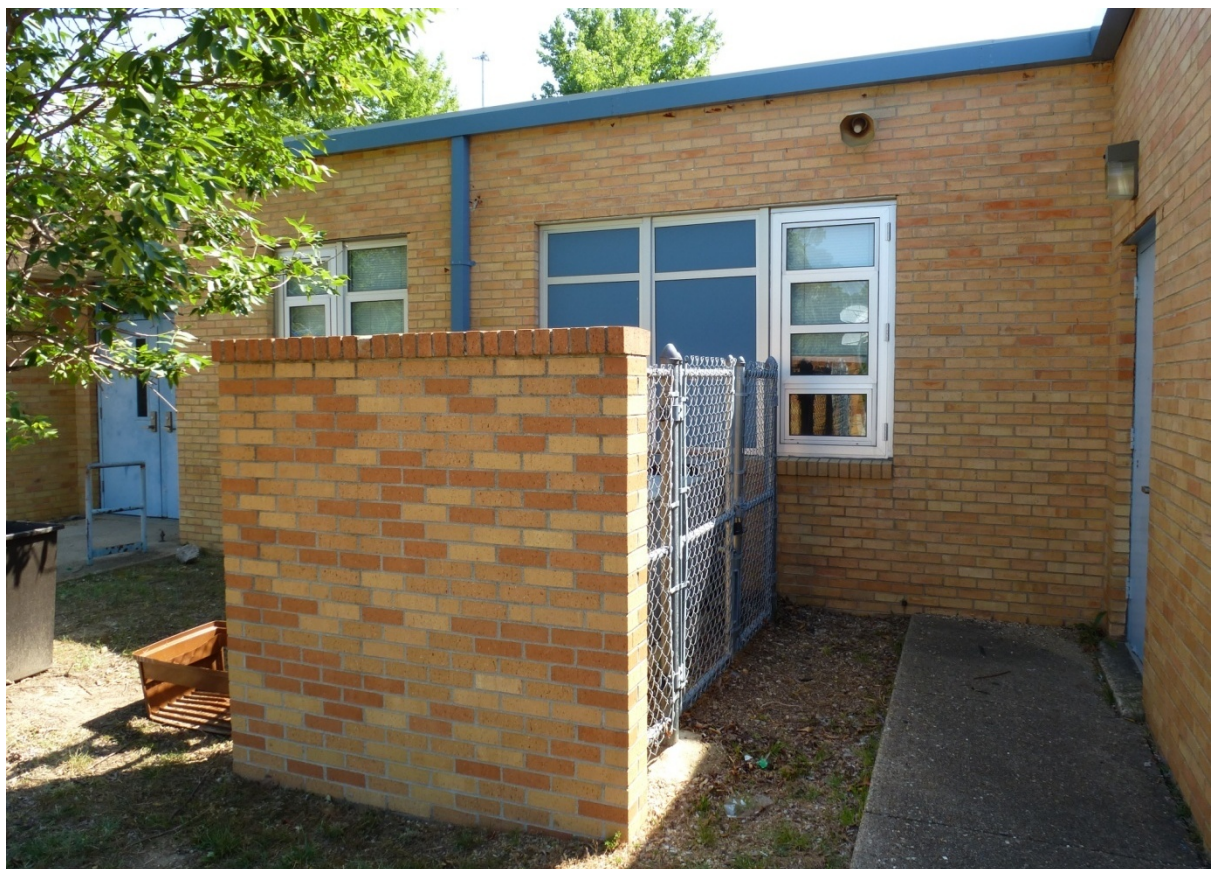
Photo 20. Replacement windows and air conditioning unit addition on the west elevation of the original school (ERDC-CERL, 2012).

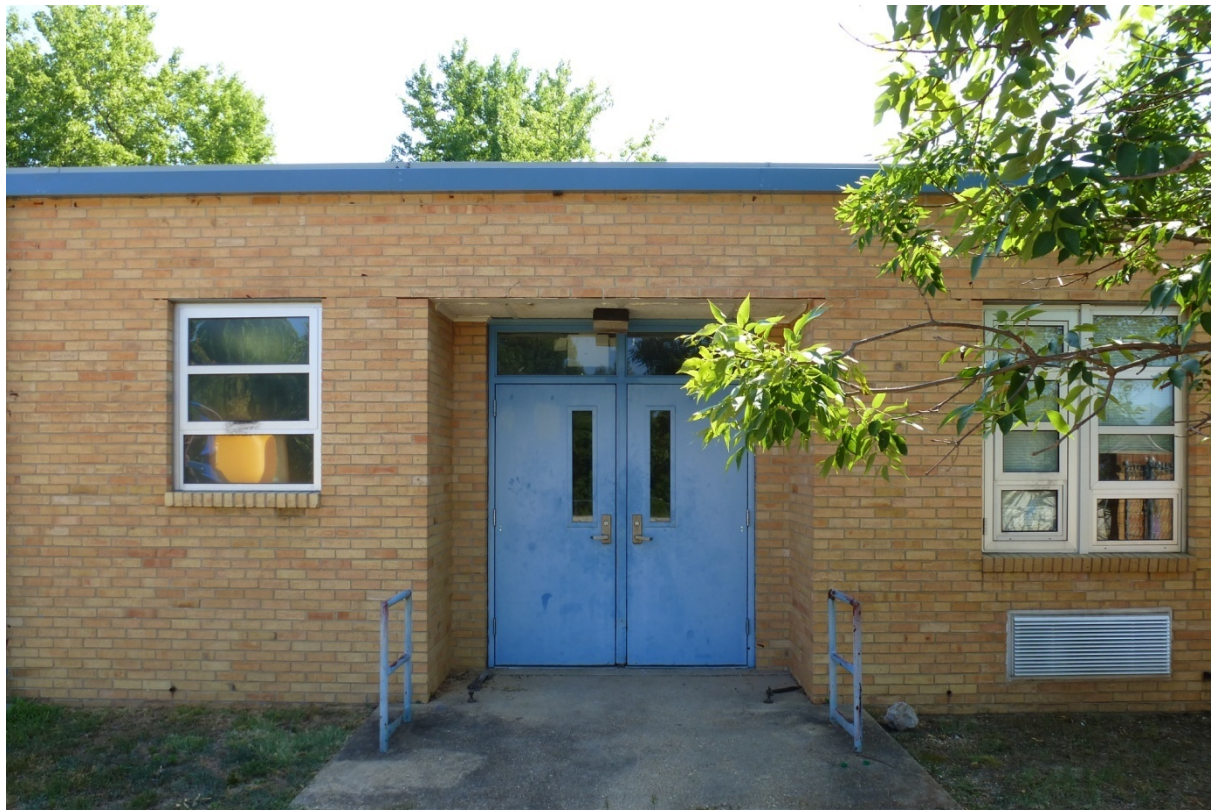
Photo 23. Replacement metal entry doors leading into the east-west corridor of the original school (ERDC-CERL, 2012).

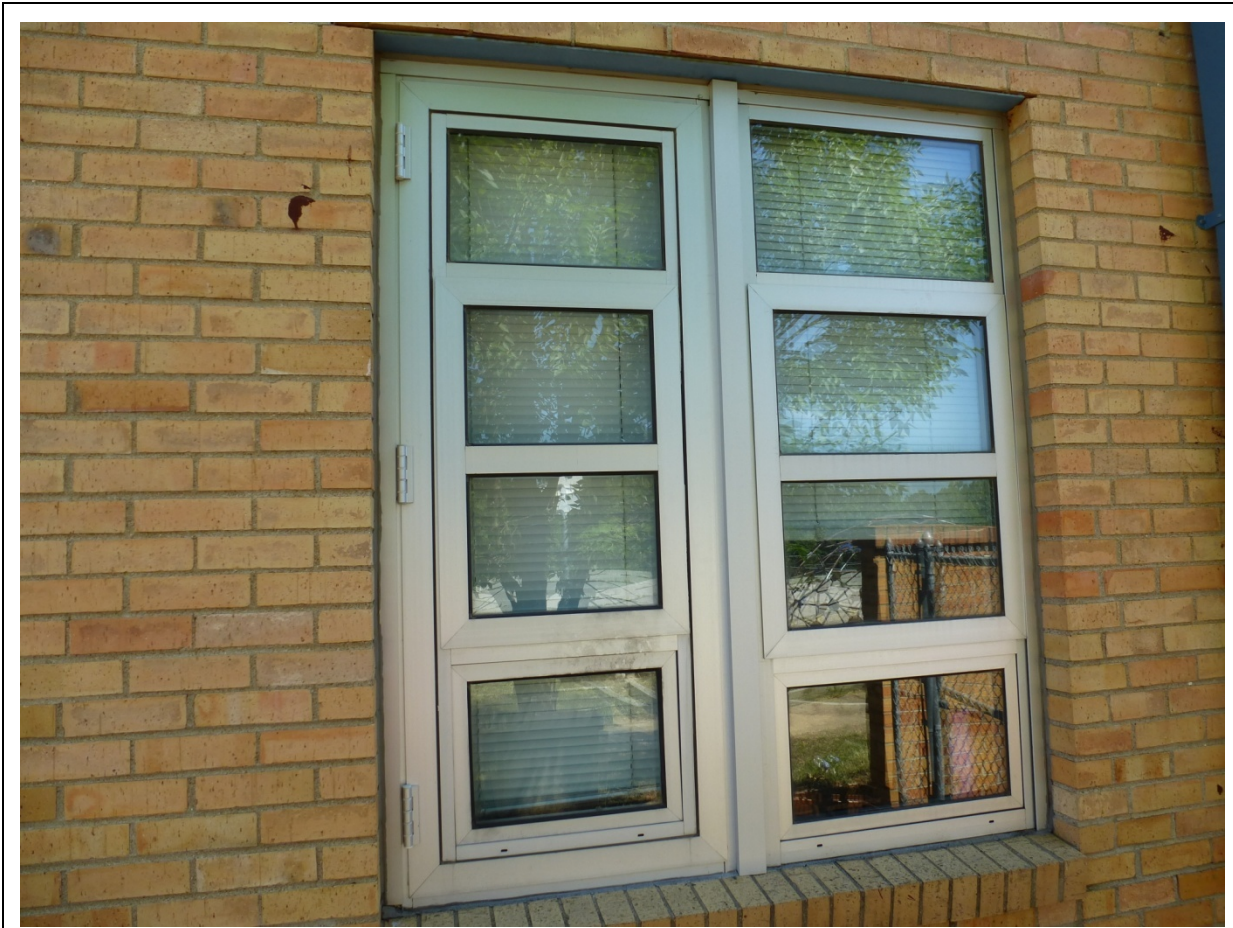
Photo 25. Replacement bright aluminum egress windows (ERDC-CERL, 2012).

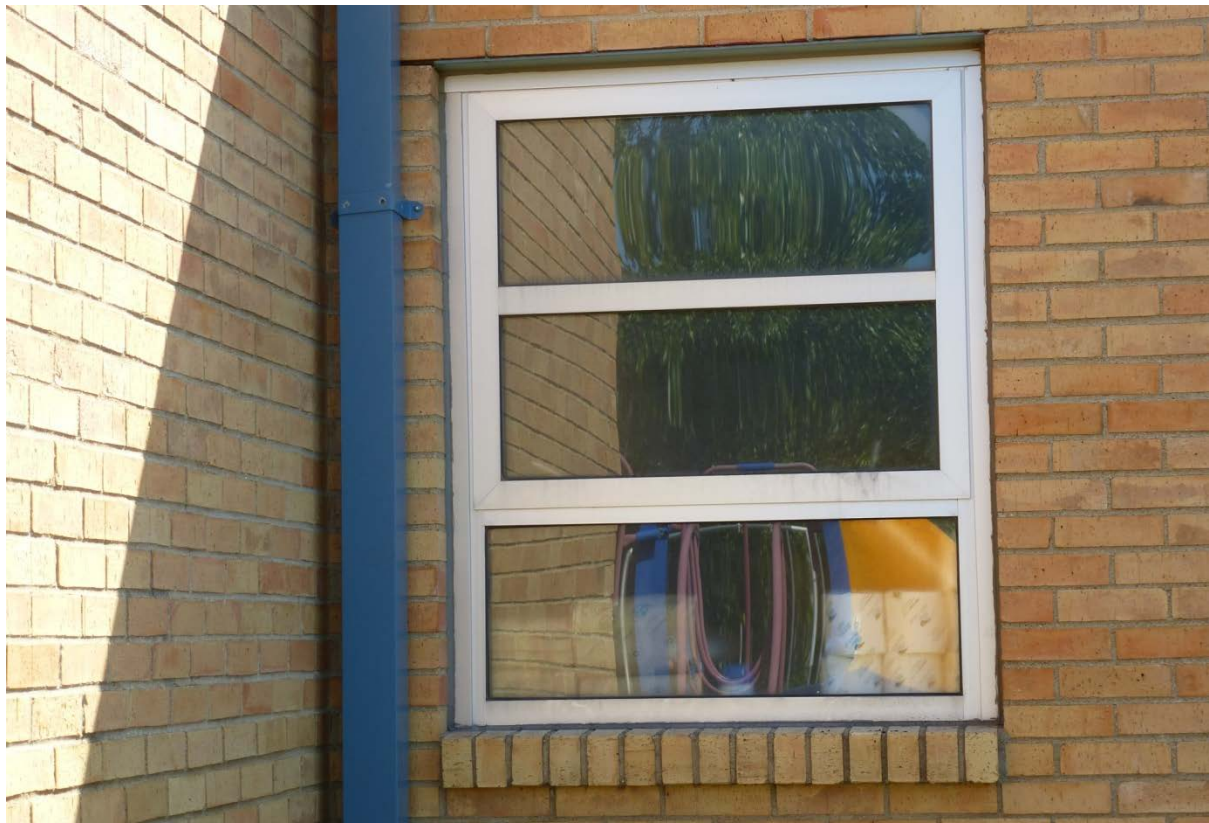
Photo 26. Replacement bright aluminum three-pane awning window (ERDC-CERL, 2012).

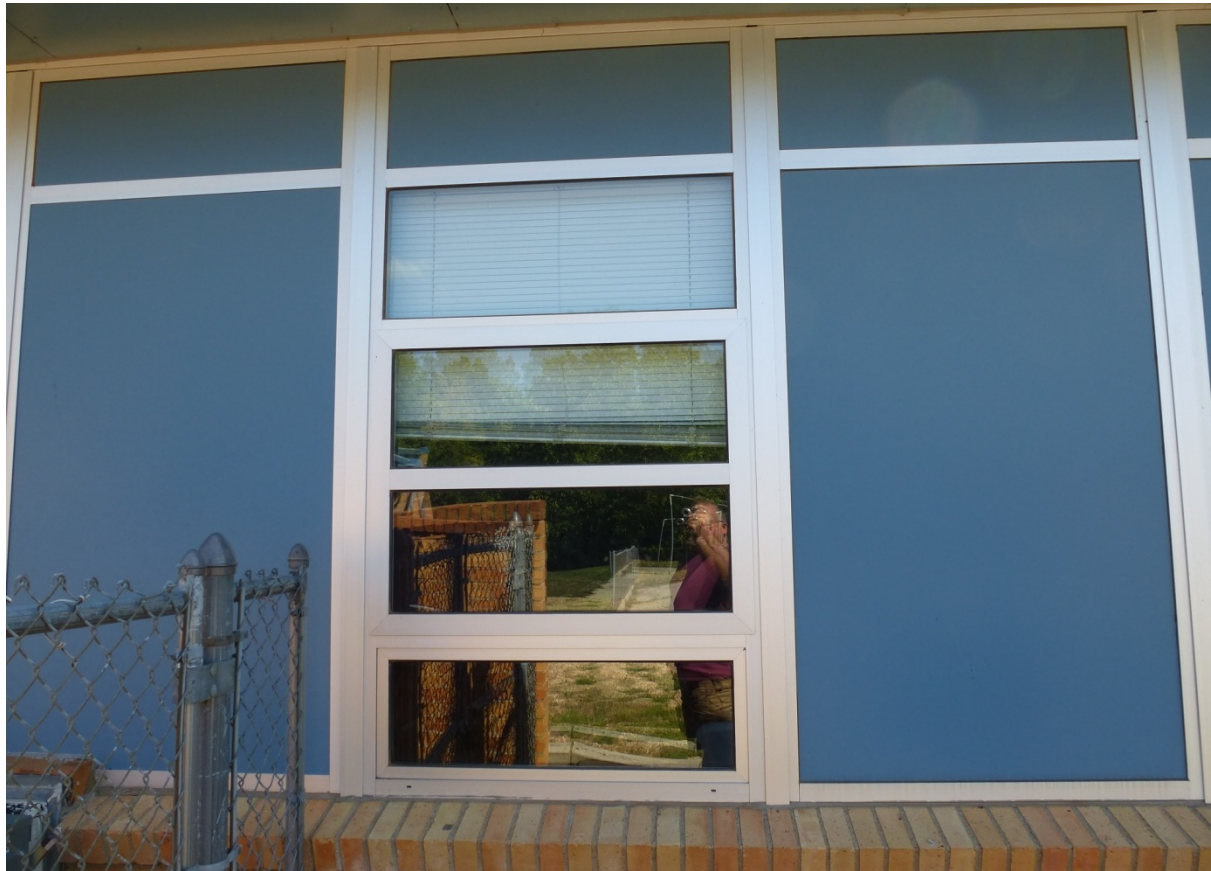
Photo 29. Close-up of replacement window and panel inserts (ERDC-CERL, 2012).

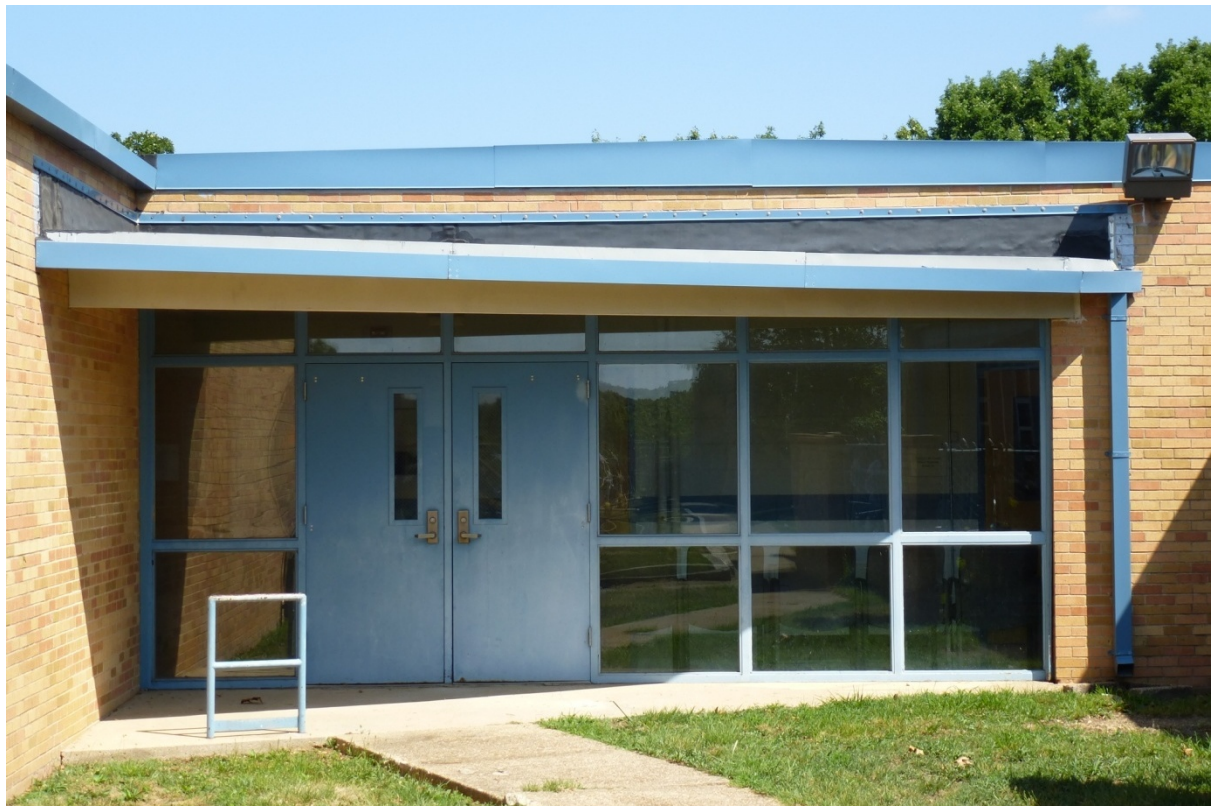
Photo 31. Entry on the south side of the 1957 addition. The windows and angled canopy structure are original to the 1957 design and construction, while the entry doors are replacement (ERDC-CERL, 2012).

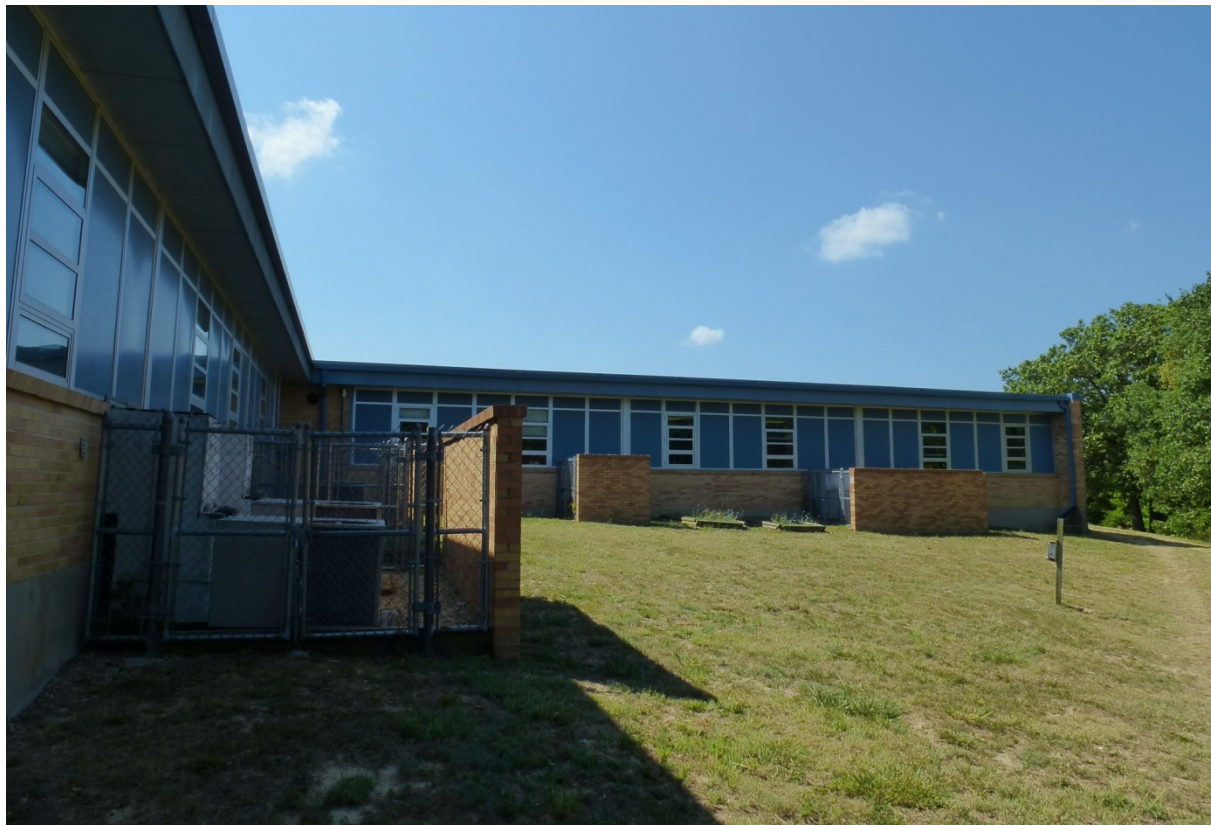
Photo 35. Right side of the north elevation with modified window pattern. Left side is 1957 addition and right side 1984 addition (ERDC-CERL, 2012).

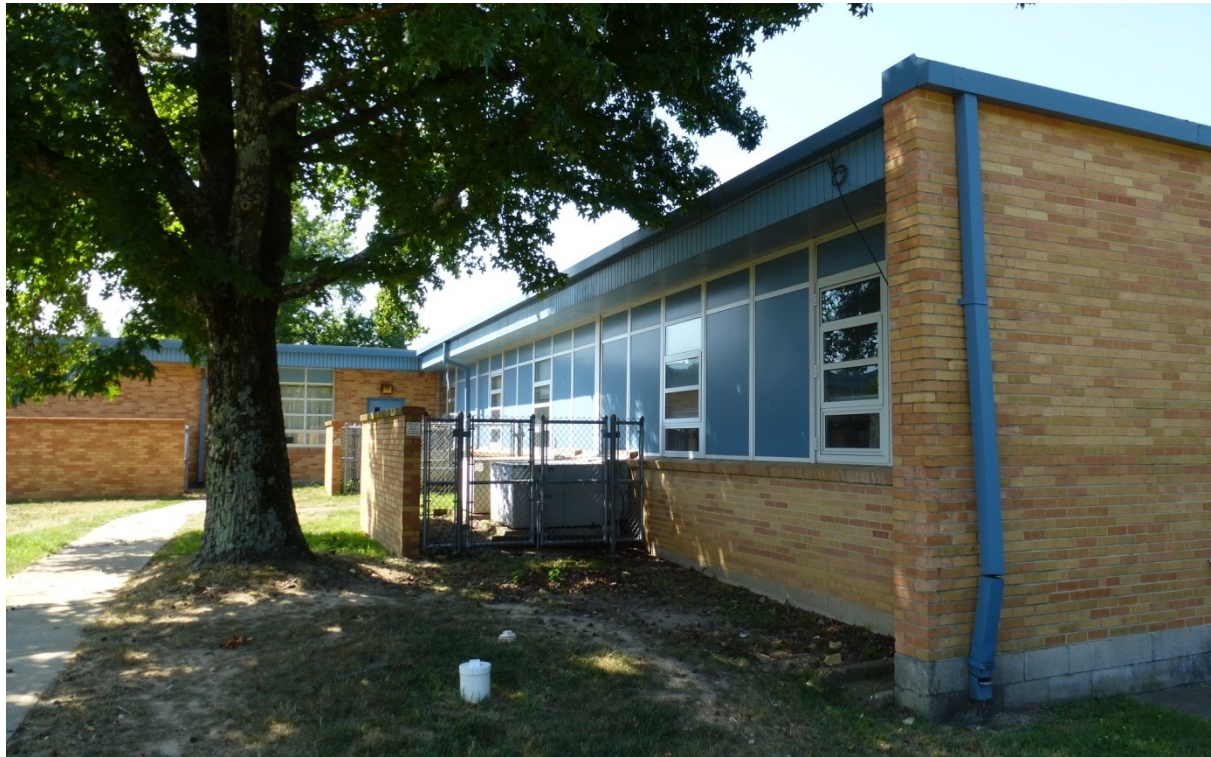
Photo 39. East elevation of 1957 addition with modified window pattern (ERDC-CERL, 2012).

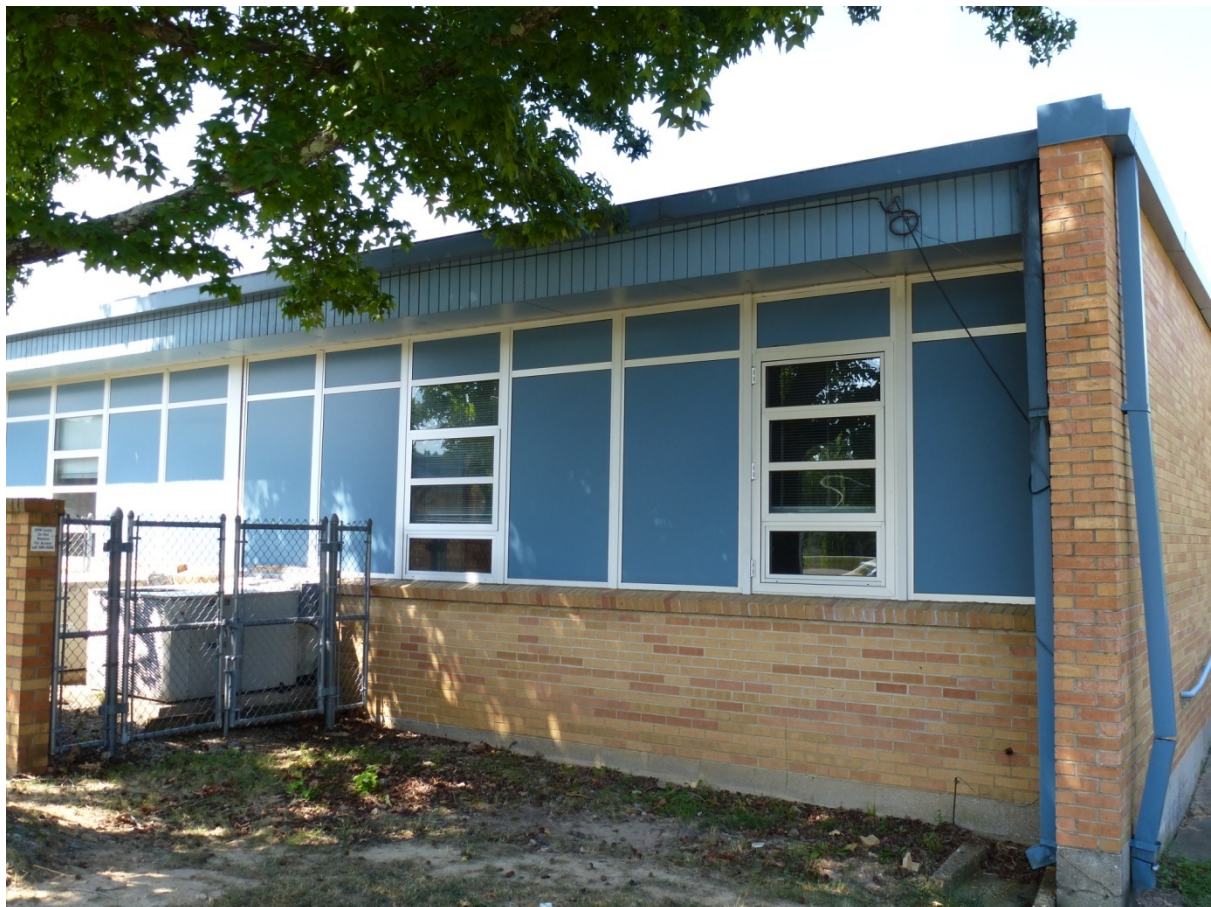
Photo 40. Closeup of bright aluminum replacement windows and panel inserts (ERDC-CERL, 2012).

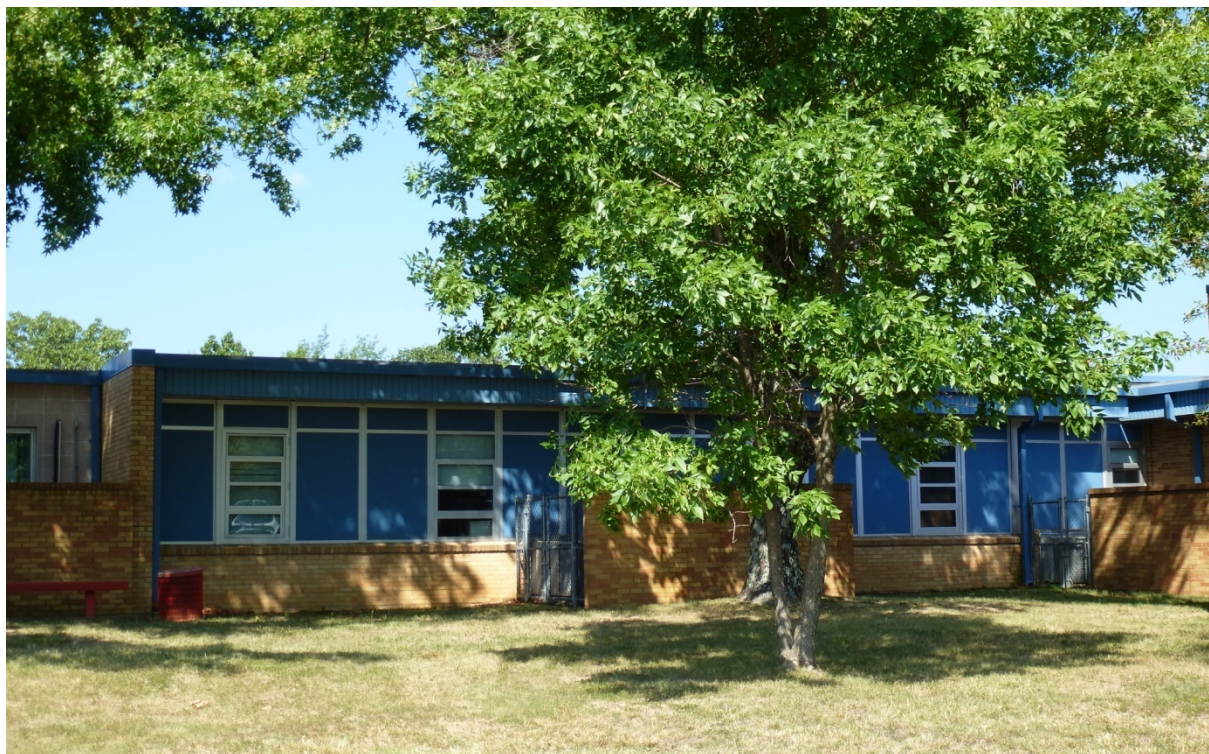
Photo 48. East elevation of the original school building with modified window pattern of replacement bright aluminum windows and panel inserts (ERDC-CERL, 2012).
